Contract #: 04-0120F4Cty: SF/ALA Rte: 80 PM: 13.2/13.9File #: 69.28**WELDING INSPECTION REPORT****Resident Engineer:**Pursell, Gary**Address:** 333 Burma Road**City:** Oakland, CA 94607**Report No:** WIR-013278**Date Inspected:** 18-Feb-2010**Project Name:** SAS Superstructure**OSM Arrival Time:** 700**Prime Contractor:** American Bridge/Fluor Enterprises, a JV**OSM Departure Time:** 1900**Contractor:** Zhenhua Port Machinery Company, Ltd (ZPMC), Changxing Island **Location:** Shanghai, China**CWI Name:** Du Zhi Qun, Li Lin**CWI Present:** Yes No**Inspected CWI report:** Yes No N/A**Rod Oven in Use:** Yes No N/A**Electrode to specification:** Yes No N/A**Weld Procedures Followed:** Yes No N/A**Qualified Welders:** Yes No N/A**Verified Joint Fit-up:** Yes No N/A**Approved Drawings:** Yes No N/A**Approved WPS:** Yes No N/A**Delayed / Cancelled:** Yes No N/A**Bridge No:** 34-0006**Component:** Tower**Summary of Items Observed:**

WEST TOWER LIFT 2

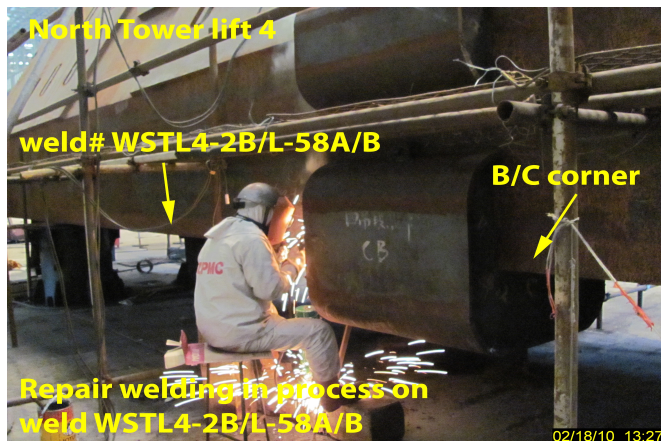
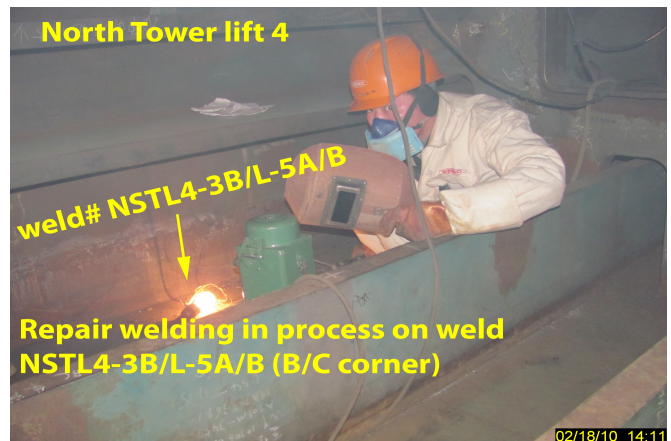
Unless otherwise noted, all work observed on this date appeared to generally comply with applicable contract documents.
